# Manhole Inspection Summary

Manhole # S53U1\_004MH

Insp Date: **4/23/09 10:59 AM**

**Location** Address: **2000 Frankfurst Ave.**

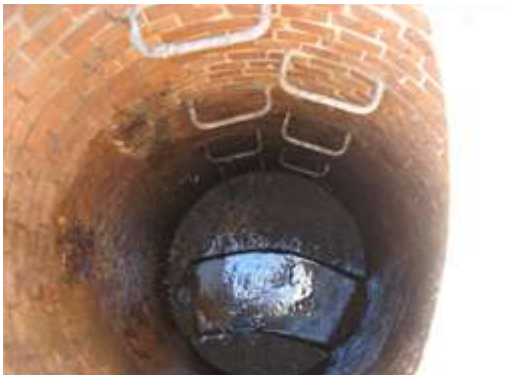
Steps

**Steps** Count: **7** Missing: **0** ☐ Corroded

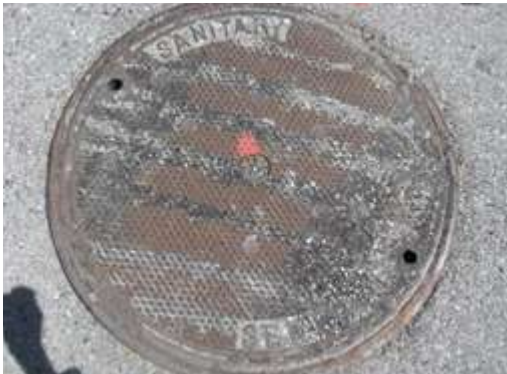
Cover

**Cover** Shape: **Circular** Diameter: **30** (in.) Length: (in.) Dist A/B Grade: **0** (in.)

Condition: **Sound**

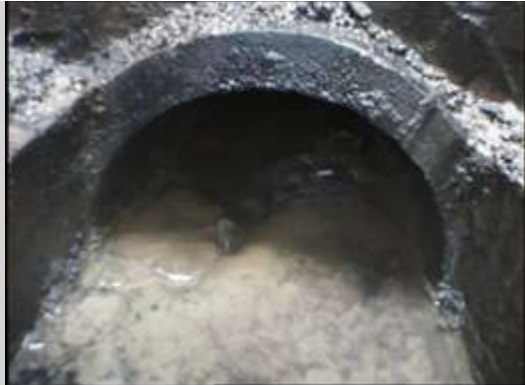
12 O'Clock Outflow

18 in. Circular Gravity Sewer  
Pipe Out @ 12 O'Clock

Pipe Height: **14.4** (in.) Rod and Bar (Angled)  
Pipe Material: **Clay** ☐ Pipe Lined  
Invert Depth: **11.50** (ft.) Flow Characteristics: **Slow**  
Deposits: ☒ None ☐ Mud ☐ Sludge ☐ Debris ☐ Grease  
Silt Depth: (in.) Deposits Extent:  
Infiltration: **None** Pipe Seal Cond: **Sound**

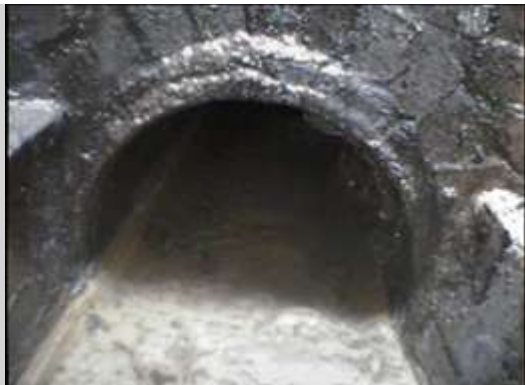
7 O'Clock Inflow

18 in. Circular Gravity Sewer  
Pipe In @ 7 O'Clock

Pipe Height: **18** (in.) Rod and Bar (Angled)  
Pipe Material: **Clay** ☐ Pipe Lined  
Invert Depth: **11.70** (ft.) Flow Characteristics: **Slow**  
Deposits: ☒ None ☐ Mud ☐ Sludge ☐ Debris ☐ Grease  
Silt Depth: (in.) Deposits Extent:  
Infiltration: **None** Pipe Seal Cond: **Sound**
